Manhole Inspection Summary

Manhole # S11O__026MH

Insp Date: **4/15/08 11:34 AM**

Location Address: **507 Wellesley St**

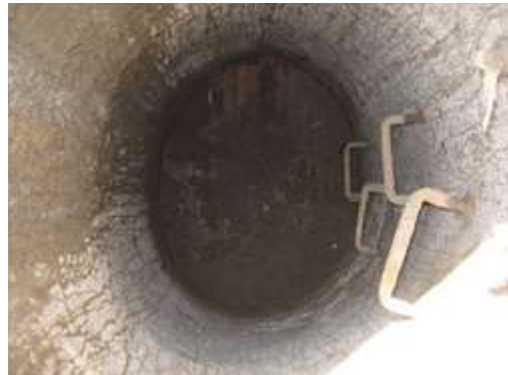
Top View

infiltration at chiney and corbel

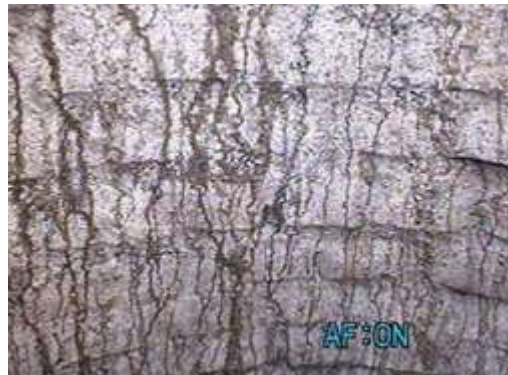
Defect 4

infiltration along barrel wall

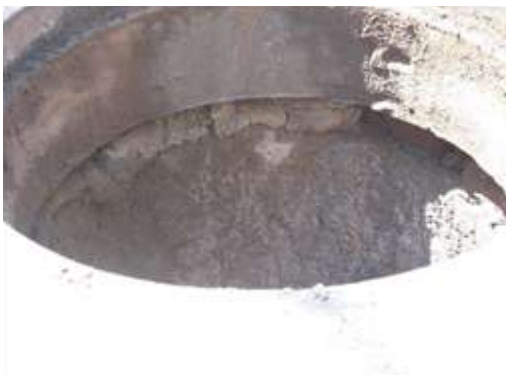
Defect 3

infiltration at frame and Chimney

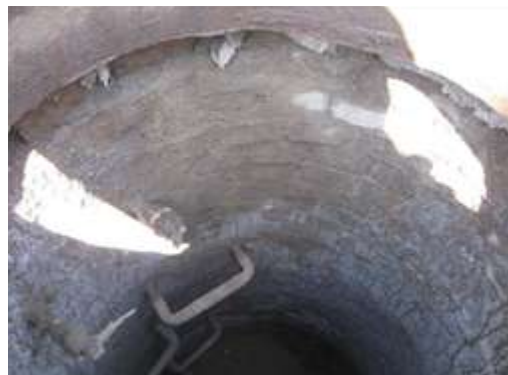
Defect 2

Condition: ☐ Sound ☐ Cracked ☐ Root Intrusion ☒ **Loose Brick** ☐ Deteriorated

loose bricks and mortar under frame

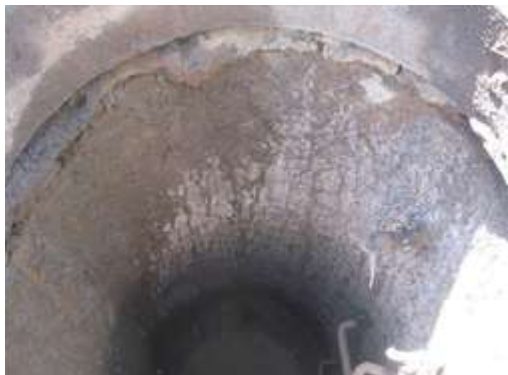
Defect 5

☒ **Leaks**

frameleaks, Chimney and corbel infiltration

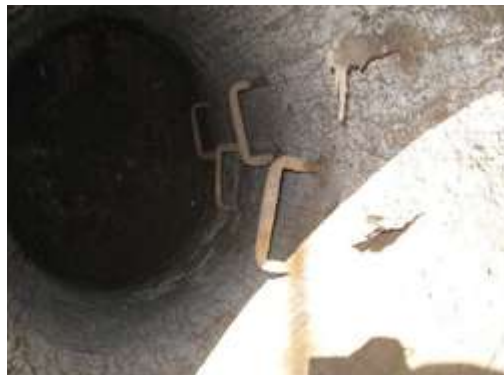
Defect 1

Count: **4** Missing: **1** ☒ **Corroded**

Corroded steps (1missing)

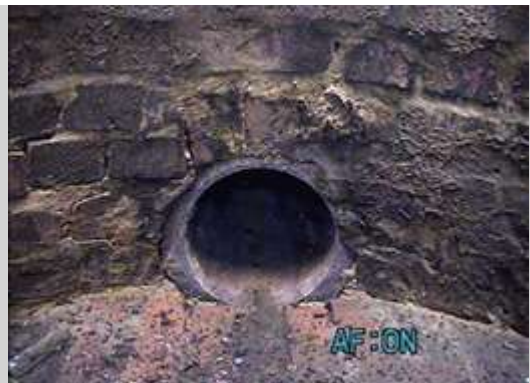
12 O'Clock Outflow

8 in. Circular Gravity Sewer
Pipe Out @ 12 O'Clock

Infiltration: **None** Pipe Seal Cond: **Sound**
